FAILURE ANALYSIS OF SKID PIPE LEAKS IN WALKING BEAM TYPE REHEATING FURNACE APPLICATIONS

ABSTRACT: This study investigates the failure of skid pipes within a walking beam reheating furnace at PT. X, Cilegon City. Visual inspection, chemical composition analysis, and corrosion rate evaluation revealed physical damages such as cracks, black and white scale deposits, bulging, and a 47% reduction in pipe thickness from the original 25 mm. The damage mechanism is initiated by high levels of Fe oxides causing corrosion with a dominant wustite (FeO) phase, and elements such as Ca, Mg, and Si contributing to scale formation. High water hardness (82.02 mg/L in pipe circulation) also supports scale formation. The LSI and RSI indices indicate highly aggressive water with high corrosiveness, causing localized overheating of the skid pipes. This increases the creep rate due to refractory damage, leading to high-temperature exposure and subsequent pipe leakage marked by bulging. Enhanced slag control within the reheating furnace, routine slag cleaning, and a review of cleaning schedules and frequencies to prevent similar failures.

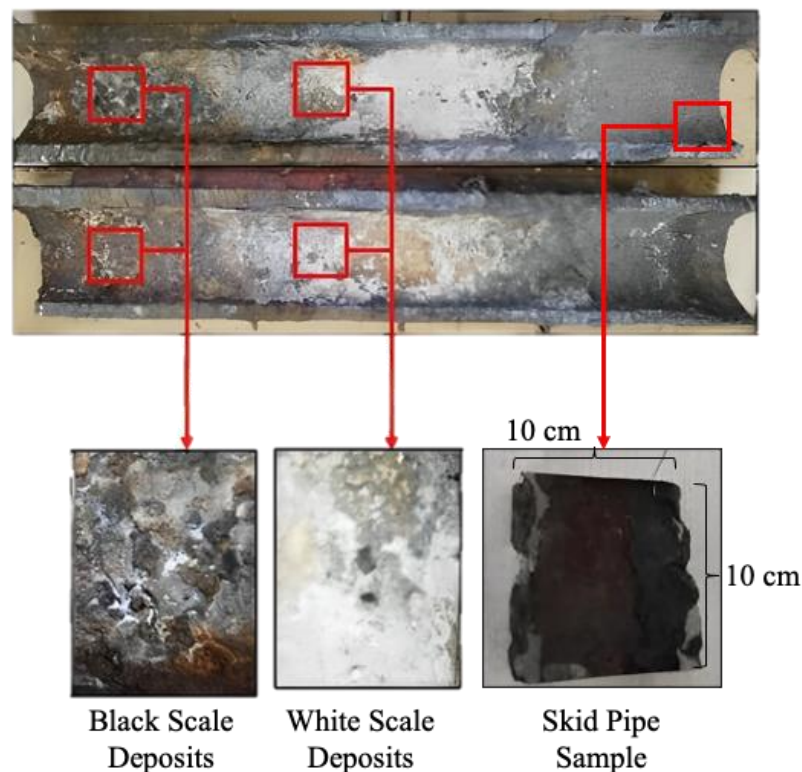
Fig. 1. Vertical pipe cut for scale and skid pipe samples

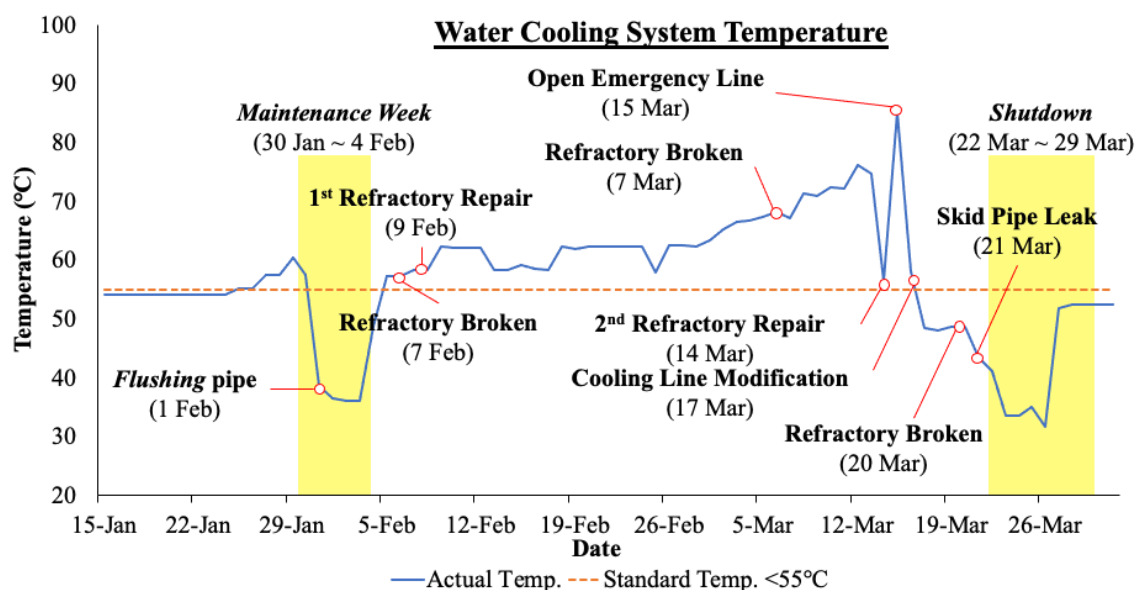
Fig. 2. Timeline of failure in skid pipes

On January 29, 2023, the highest recorded temperature was 60.3°C, prompting flushing of the skid pipes during maintenance week. However, by February 7, 2023, after maintenance, the temperature remained at 58.2°C. Field checks revealed minor refractory damage, which was repaired using the spray method on February 9, 2023. However, this did not reduce the drain box's cooling system temperature or water flow rate. On March 7, 2023, the temperature rose to 67.1°C, causing further refractory damage. The second repair on March 14, 2023, was followed by an extended repair period that caused creep in the skid pipes. By March 15, 2023, the temperature peaked at 85.2°C, indicating blockages in the skid pipes. An emergency cooling water route was opened, reducing the temperature to 58.1°C. On March 17, 2023, a modified cooling water supply route was implemented by adding a new pipe, effectively reducing the temperature to 48.1°C. Despite these efforts, severe refractory damage occurred on March 20, 2023, and on March 21, 2023, a leak in the skid pipes halted production for repairs and investigation. The condition of the refractory and skid pipes is shown in Fig. 3.

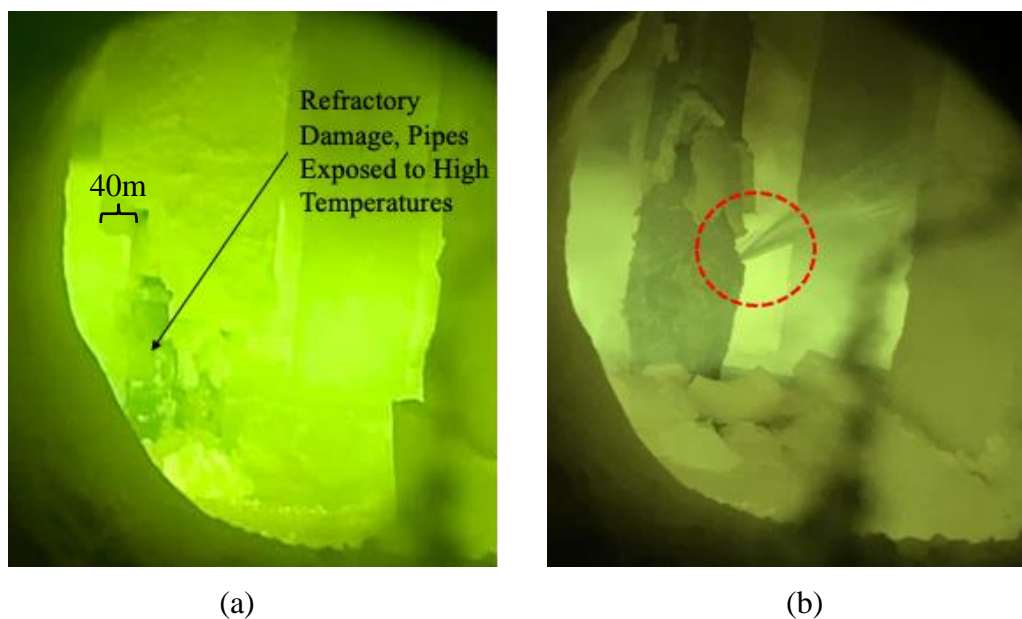
Fig. 3. Skid pipe condition (a) before leak (b) during leak

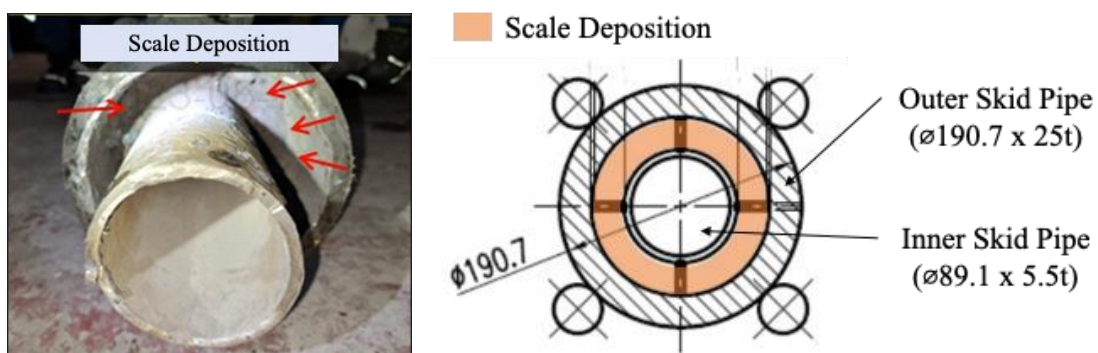
The investigation into the skid pipe leakage in the reheating furnace began by cutting the pipes, revealing significant scale deposits inside (Fig. 4). These blockages indicate poor cooling water quality, characterized by high hardness, alkalinity, and temperature, which leads to scale formation and corrosion. This, in turn, reduces heat transfer efficiency and causes localized overheating, exacerbating creep in the pipes [13]. The problem is worsened by the position of the skid pipes directly in front of the burner mouth (Fig. 5).

Fig. 4. Scale blockage inside the pipe

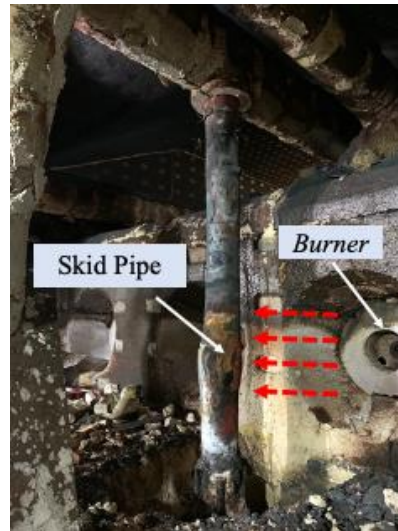
Fig. 5. Position of skid pipe to burner

3. **Need for Slag Control:** Prioritizing slag control within the reheating furnace is crucial, leading to refractory damage through abrasion. Therefore, routine slag cleaning and a review of cleaning schedules and frequencies are required.

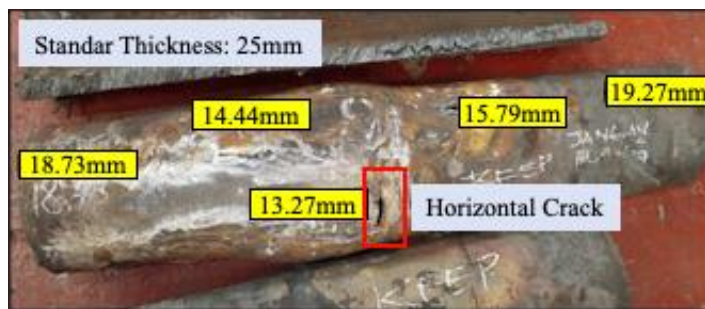
A visual inspection of the skid pipes in the reheating furnace revealed significant leakage issues. After longitudinally cutting the pipes, measurements showed the pipe thickness reduced from 25 mm to 13.27 mm (47% reduction) near the crack and to 19.27 mm (23% reduction) farther from the crack (Fig. 6). A horizontal crack of approximately 10 mm was found (Fig.7). The pipes experienced severe vibrations, impacts, and abrasion due to the cylinder's movement, leading to creep and bulging (Fig. 8) [14]. Internal scale deposits indicated uneven heating, causing localized overheating and thick oxide layer formation, weakening the pipe walls and increasing stress [15]. Iron oxide layers inside the pipes (Fig. 9) were due to high temperatures from cooling system blockages, accelerating oxidation [16].

Fig. 6. Thickness distribution

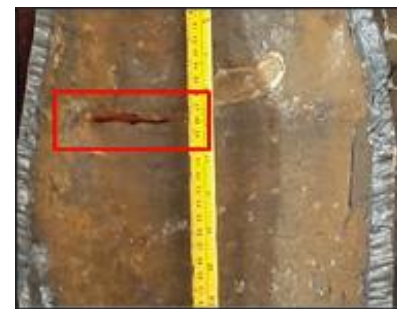
Fig. 7. Crack condition

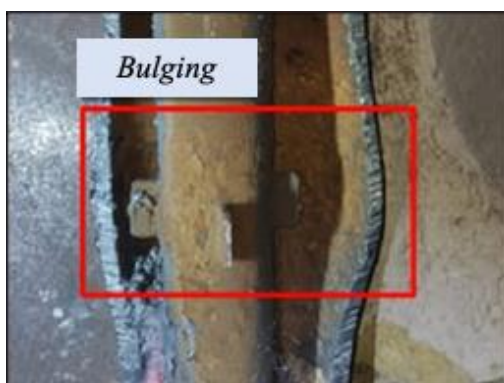
Fig. 8. Bulging Phenomenon

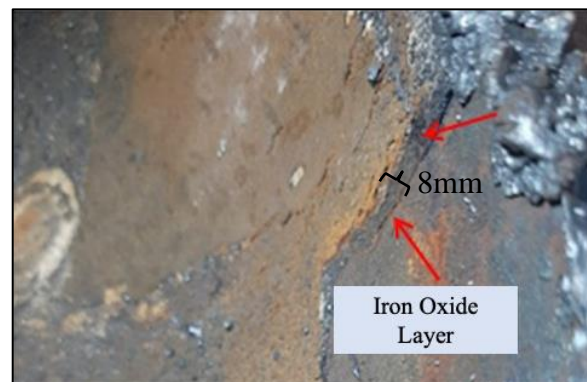
Fig. 9. Iron oxide layer formation
