## FATIGUE FAILURE ON DRILLING PIPE THREAD: A CASE STUDY ON DRILL PIPE SS105

AFRIANSYAH<sup>1,2\*</sup>, HENDRI CHANDRA,<sup>1</sup> DIAH KUSUMA PRATIWI<sup>1</sup>, ANEKA FIRDAUS<sup>1</sup>

<sup>1</sup>PT. Pertamina Drilling Project South Sumatera, Prabumulih, South Sumatera, Indonesia

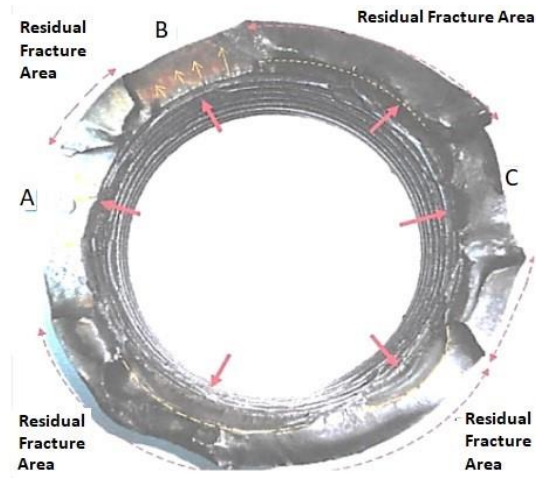
Fig. 1. Macro mapping frictional drill pipe

Fig. 1 shows that the failure occurs in the area close to the drill pipe thread. Besides, on the inner surface of the fault appears fatigue fracture at various points occurring up to  $\frac{3}{4}$  of the

thickness, which the remaining part is a static fracture. This is located outside and marked with a groove residual example of A, B, and C.

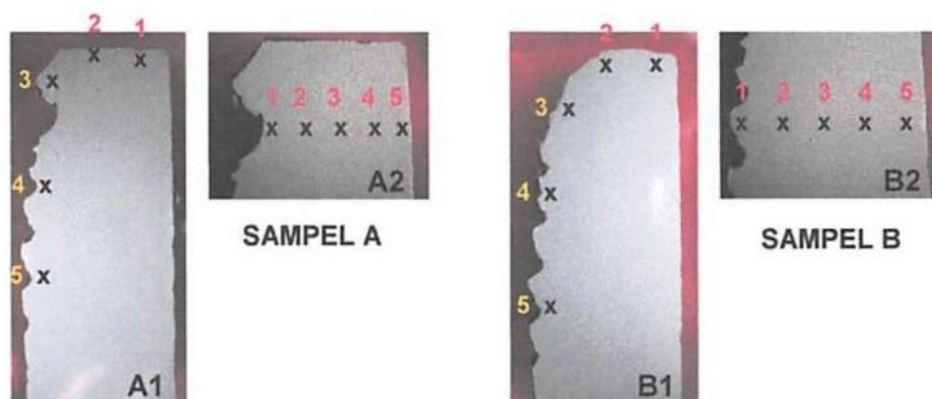
Fig 2. Sample for hardness test

From Fig. 2, we conduct a hardness test for the part of failure with the Rockwell hardness test and tensile test. Before the test, we separate material into two samples are sample A and B, each sample we conduct test hardness test, Hardness testing is carried out with two tests, namely carried out on the edge of the fault and in the middle of the fault, each of which is carried out five points.

The result showed based on table 3, for sample A1 found average Hardness number is 32.5 HRC with maximum hardness at point 1 (at the top sample). For the sample, A2 found the average hardness number is 33.7 with maximum hardness at point 5 (at edge sample). For sample, B1 found average hardness number is 32.2 with maximum hardness at point 1 (at the top sample) and for sample, b2 found average hardness number is 32.6 with maximum hardness at point 5 (at edge sample). In conclusion, the hardness of the fractured part is more than the hardness standard material. It is related to the % C material from the composition test before.

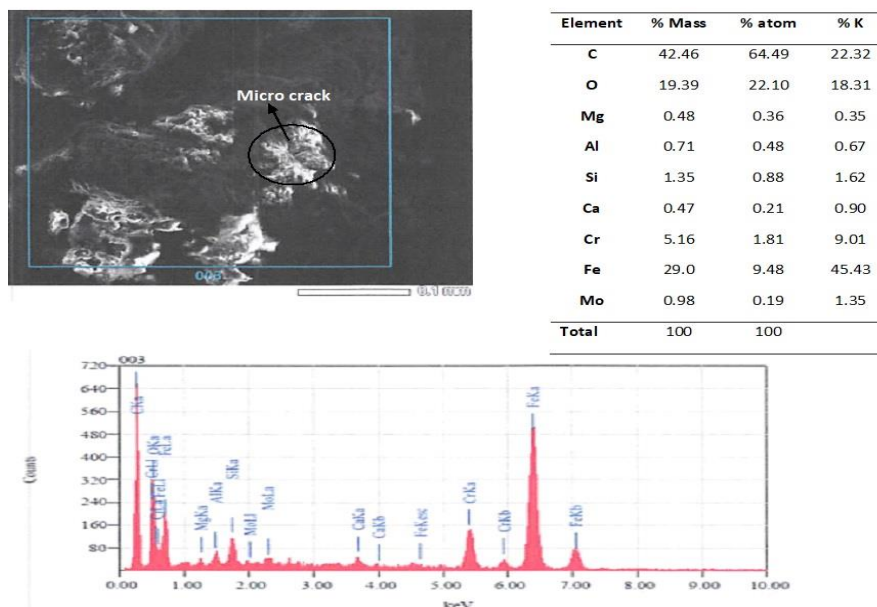
Fig. 3. SEM and EDX at the surface fracture

Fig. 3 showed SEM and EDX results on the surface fracture drill pipe. The image clearly shows the “white area” is ferrite. Based on the EDX spectrum, value Fe, C, and O is the highest value on the surface fracture. On the surface, fracture showed there are micro-cracks. Furthermore, there is an iron oxide (FeO) on the surface fracture. It can be formed by element Fe and element O based on EDX analysis.

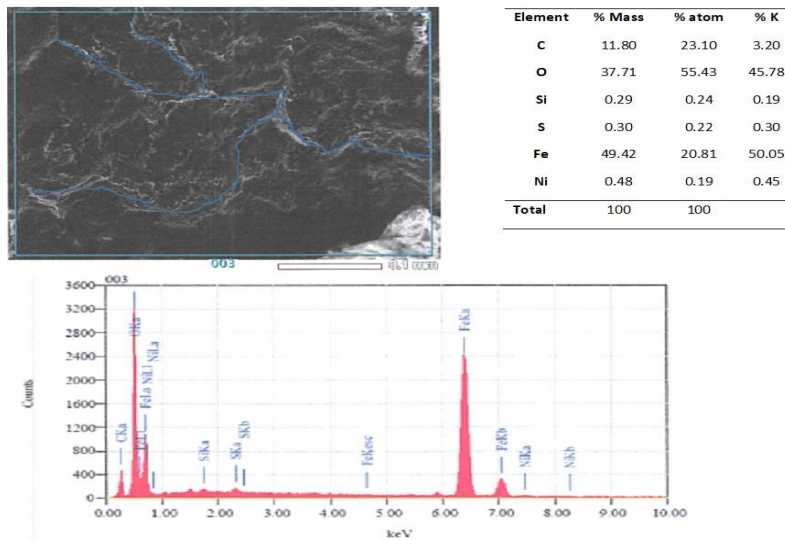
Fig. 4. SEM and EDX Inner Surfaces fracture

Fig. 3.4 showed SEM and EDX results on the inner surface fracture drill pipe. There are SEM images and EDX graphic charts that showed an element of inner surface fracture.

The image clearly shows a crack along the grain boundary. Based on the EDX spectrum, value Fe, C, and O are the highest value on the inner surface fracture (thread drill pipe). The crack surface is flat and has a grainy texture as a result of changes in orientation of the cleavage planes from grain to grain. Crack propagation is along grain boundaries (intergranular)

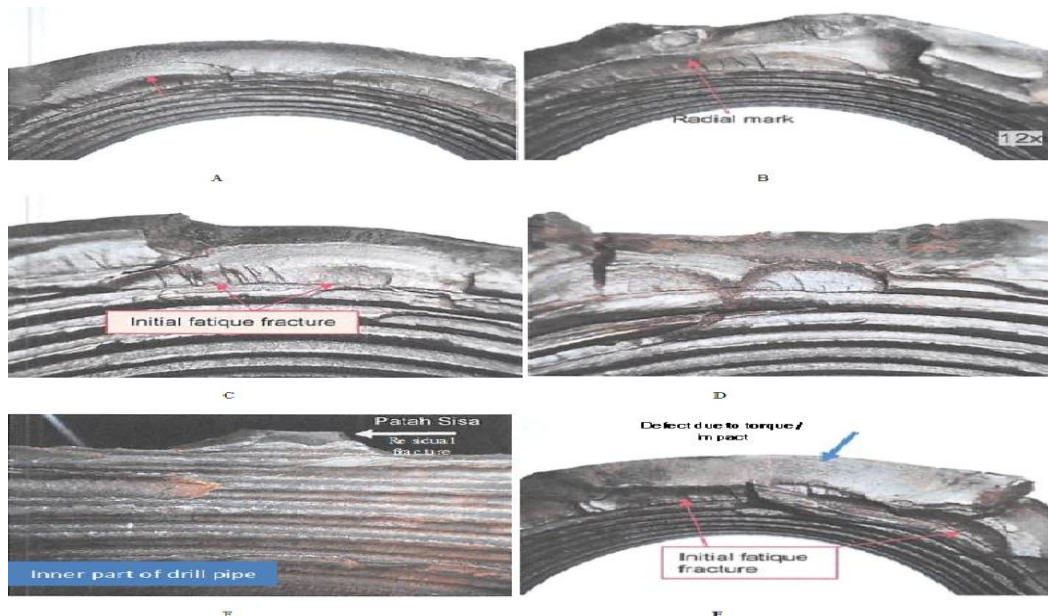
Fig. 5. Result fractography on inner surface drill pipe

The fractographic analysis is carried out on the failure drill pipe. Fig. 5 showed result fractography on the inner surface drill pipe after 25 times the enlargement is conducted to determine the sign from the initial phase of the fault.

Fig. 5. A & B showed a radial mark on the inner surface of the drill pipe. C & D showed initial fatigue fracture on the surface fracture. D showed residual fracture on the inner surface. E showed Initial fatigue fracture and defect due to torque/impact. The macro photo on the

threaded Fig. 5 C, D, and F showed the beginning of the crack starting from the thread's inner leg (C and D). Radial mark on Fig. 5 A and B caused by fatigue fracture. Surface fracture is flat and there is a residual fracture on the surface (Fig. 5E).

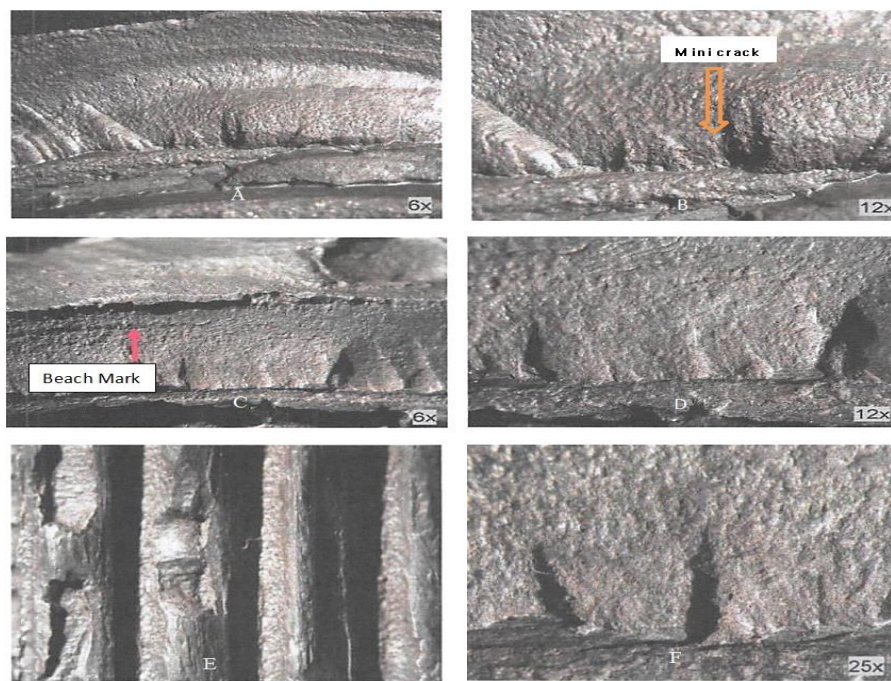
Fig 6. Preliminary Macro Crack Photo (threaded detail)

Fig. 6 showed Preliminary Macro Crack Photo after enlargement 6X and 12X. It showed a thread image on a drill pipe connection that has been a failure.

Fig. 6. A and B showed Preliminary Macro Crack Photo (threaded detail) magnification 6x and 12x. C and D showed the beach mark on surface fracture with magnification 6x and 12x. E and F showed crack on the thread of the drill pipe with magnification 6x and 25x.

Macro photo 6A showed part of threaded. Arrow showed a beach mark area. Fig. 6B showed a mini crack on the thread drill pipe. The surface fracture is flat. Therefore, it is a fatigue fracture. Macro photo from magnification from Fig. 6C and 6D shows the beginning of the fault starting from the threaded leg, marked with visible beach marks on the arrow. Photo 6E and 6F showed condition thread after fracture after enlargement 6X and 25X. It showed a fracture from the Last engaged thread (LET). This condition suitable for McDonald's had found [12].

In this study, the following were analyzed the failure due to fatigue on the drill pipe, especially on the thread section, was caused by the initial micro-cracks and its spread which is usually triggered by the amount load received by the pipe during the drilling process. Besides, the fatigue cracks on the threads usually occur on the first threaded or foot. To avoid similar incidents, the following should be conducted: drill pipe inspection according to DS1 standards and the strength of the drill pipe tool joint need to be increased during the manufacturing process with a heat treatment process such as quenching and tempering to eliminate residual stress in the threaded area.
