# CATASTROPHIC FAILURE INVESTIGATION OF THE OIL FILTER MACHINE BOLTS

**ABSTRACT:** An assessment of the fractured bolt of a cooking oil filter machine was performed. The objective of this assessment is to reveal the root cause of the failure. A series of necessary attempts were carried out for this analysis, i.e., site visit, fracture surface examination of the fractured bolt, collecting the maintenance and operation data, mechanical properties testing, chemical composition testing, and stress analysis. The fracture surface examination showed a catastrophic failure, especially at a repaired bolt. Meanwhile, according to the site visit investigation, some evident data indicated a sudden high-pressure load subjected to the filter machine. Most fractured filter bolts were repaired by welding. The design review shows that the critical operating pressure is around 14.5 bar, which is far above the reported operating pressure during the accident, which is 6 bar. This indicated that the strength of the genuine bolt is sufficient to ensure the operating pressure of the filter machine, which is normally 1 to 3.5 bar. Finally, it can be concluded that the root cause of the failure of the fil

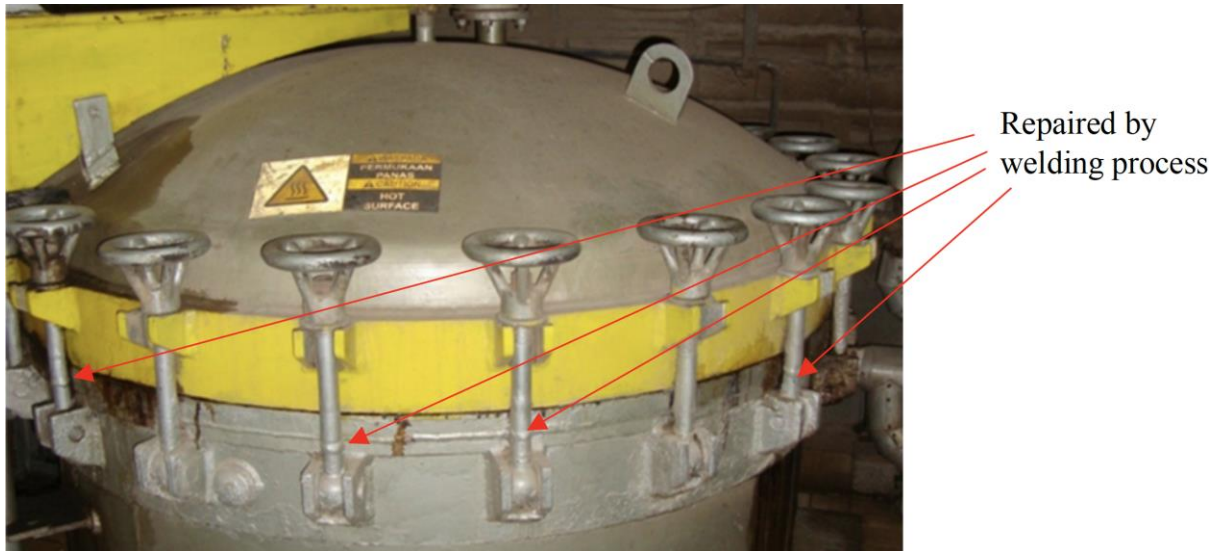
The cooking oil filter, as shown in Fig. 1, is located inside the production room of the cooking oil company [1]. The main function of an oil filter machine is to filter palm oil during production. During operation, the vessel of the palm oil filter suffers fluctuating load, normally around 1 to 3.5 bars. The cylindrical vessel filter's internal diameter is 1370 mm, and it is mounted with a dome cover tightened by 15 fastening bolts. The leaf filter machine is connected to the piping system to support and control its operation. The damage periodically occurred in the middle of the bar of the fastening bolts; however, in most cases, to reduce costs and time for procurement and replacement, the repair was carried out using welding technology repair at the bolt rod shown in Fig. 1.

Fig. 1. Oil filter vessel indicating the numerous repaired bolts by welding process.

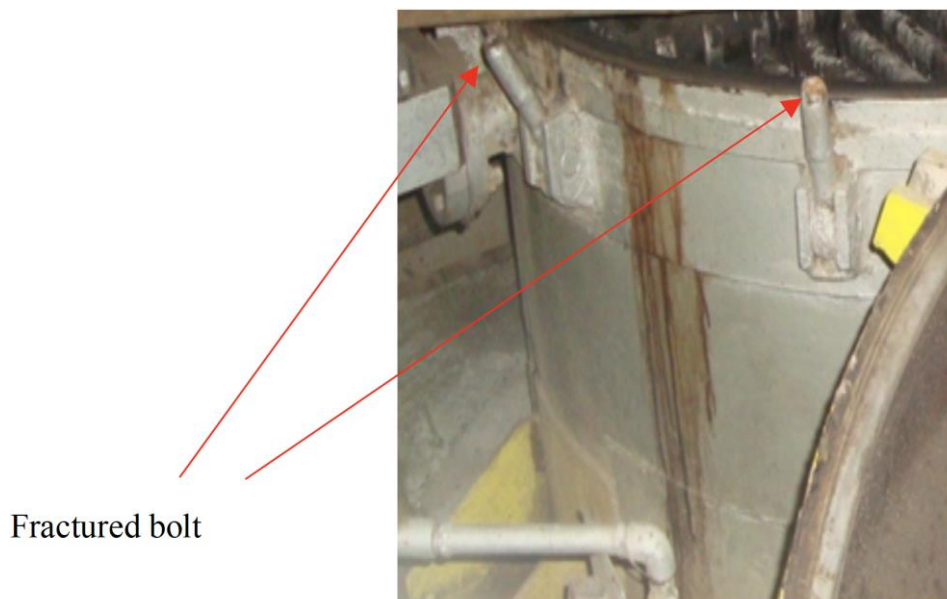
As shown in Fig. 1, a cooking oil filter bolt was reported failure during operation, as shown in Fig. 2. The fastening bolts were fractured simultaneously, which can affect serious accidents and interrupt the production process, mainly in this related line production [1]. Therefore, it is very necessary to perform a failure analysis. The main objective is to get the root cause of the failure of the fastening bolt. Some necessary attempts were performed: fracture surface examination, hardness testing, chemical composition testing, site visit examination, maintenance and operation data collection, and design review to conduct failure analysis. Several reference books on failure analysis of machine components have been used as basic

Fig. 2. Oil Filter showing the fractured bolts.

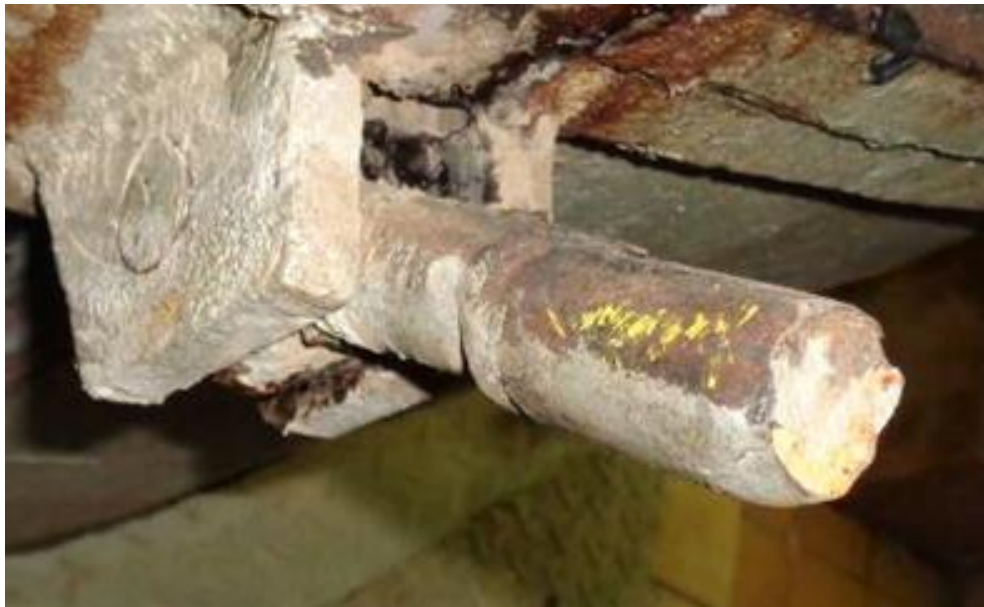
Fig. 3 to 5 show that visual fracture surface examinations were performed. Based on the observation of those Fig.s, it can be described that bolts failed mainly by ductile fracture. High tension force has occurred on the bolt and generated high tension stress significantly, as shown in Fig. 3, shown by the occurrence of necking. Visually fracture surface examination shows the

Fig. 3. Fractured bolt showing that ductile fracture was occurred.

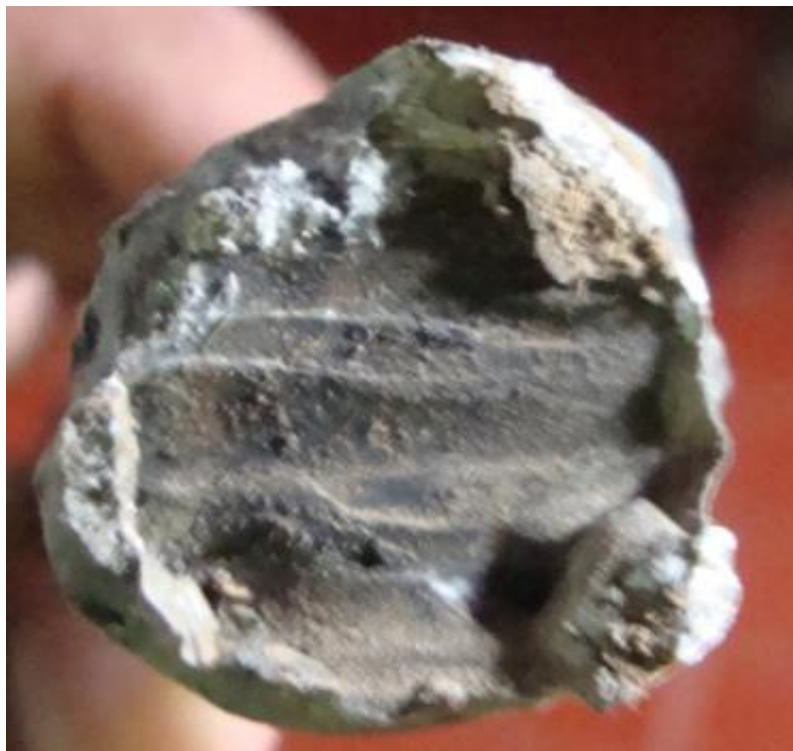
catastrophic failure of those bolts subjected to sudden high load. All bolts were fractured around welded area, indicating the area is a very critical area. Macroscopically fracture surface examination of several views for a number of fractured parts, as shown in Fig. 4 and 5, also indicated that the fracture surface around welded area was a crumpled surface, indicating that the failure was not fatigue failure. However, it is exhibited that the failure was a catastrophic failure due to a high sudden peak load.

Fig. 4. Visual view of the fracture surface of bolts showing that catastrophic fracture occurred around welded area.

Ductile Fracture (DF) dominantly controlled the bolt's welded joint strength, shown as the fracture surface's inner area. However, brittle fracture (BF) occurs circumferentially shown on the fracture surface.

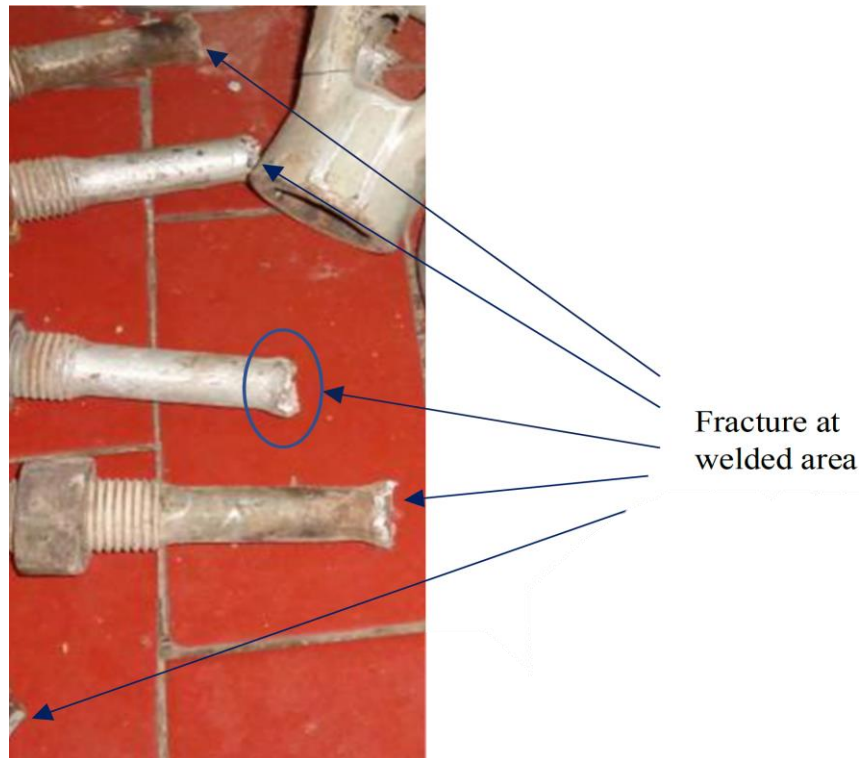
Fig. 5. Most fractured bolts, indicating catastrophic failure occurred at the welded area in the bolt bar's middle.

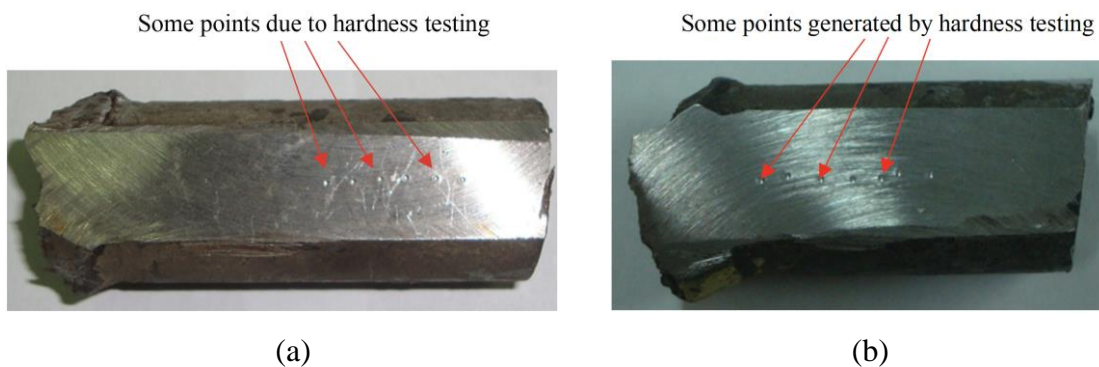
Hardness testing according to the ASTM E18 was conducted at the surface of the sliced bolt material, as shown in Fig. 6a and 6b. The hardness value of bolt material is necessary to predict its yield strength. The result can be summarized in Table 1. This estimated yield strength data is essential as input data during stress analysis of the bolt numerically.

Fig. 6. (a) Hardness testing performed for some points at bolt material of specimen 1, (b) Hardness testing carried out for some points at specimen 2.

No	Hardness (Rockwell)	Hardness (BHN)	Estimated Yield Strength (ksi)
1	100	241	118 ksi (831.45 MPa)

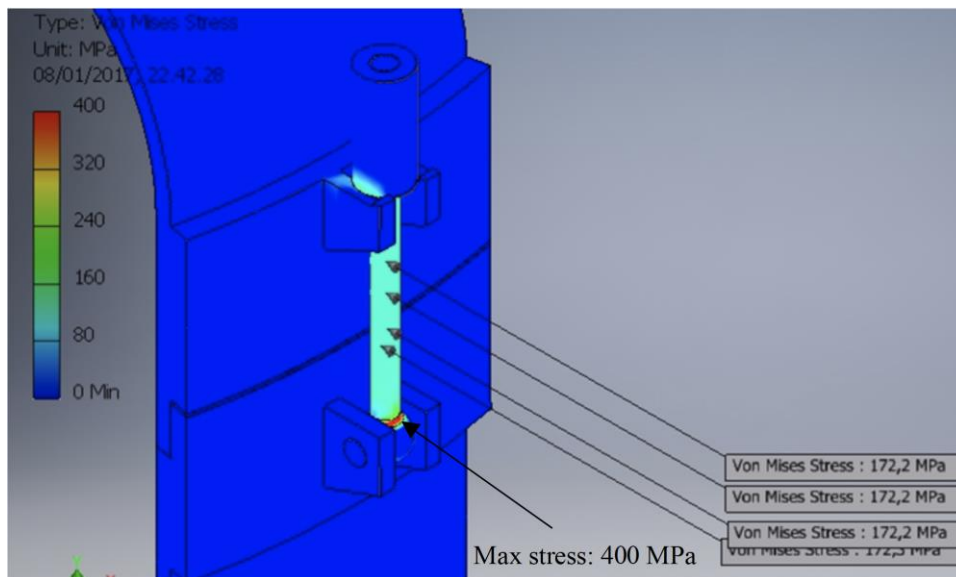
Fig. 10. Stress distributions focused on bolt bar.

As shown in Fig. 10, the maximum Von Mises Stresses is about 400 MPa, located at a radius near the bolt head. However, those maximum Vos Mises stresses do not correlate with the failure of the bolt since all bolts are fractured at the middle of the bolt shank, which is far from the maximum stress location. Meanwhile, Von Mises stresses along bolt rods are commonly around 172.2 MPa. Therefore, it could be considered that the stresses of 172.2 MPa occurred in the middle of the bolt rod, directly controlling the bolt load in normal operation.

The simulation results indicated that the internal pressure acting inside the filter vessel, which is a maximum of 6 bar, does not give excessive stress to the bolts. Therefore, it can be concluded that theoretically, the unrepaired bolts should still be in a safe condition at the time of the failure.
