# CATASTROPHIC FAILURE INVESTIGATION OF THE OIL FILTER MACHINE BOLTS

**ABSTRACT:** An assessment of the fractured bolt of a cooking oil filter machine was performed. The objective of this assessment is to reveal the root cause of the failure. A series of necessary attempts were carried out for this analysis, i.e., site visit, fracture surface examination of the fractured bolt, collecting the maintenance and operation data, mechanical properties testing, chemical composition testing, and stress analysis. The fracture surface examination showed a catastrophic failure, especially at a repaired bolt. Meanwhile, according to the site visit investigation, some evident data indicated a sudden high-pressure load subjected to the filter machine. Most fractured filter bolts were repaired by welding. The design review shows that the critical operating pressure is around 14.5 bar, which is far above the reported operating pressure during the accident, which is 6 bar. This indicated that the strength of the genuine bolt is sufficient to ensure the operating pressure of the filter machine, which is normally 1 to 3.5 bar. Finally, it can be concluded that the root cause of the failure of the fil

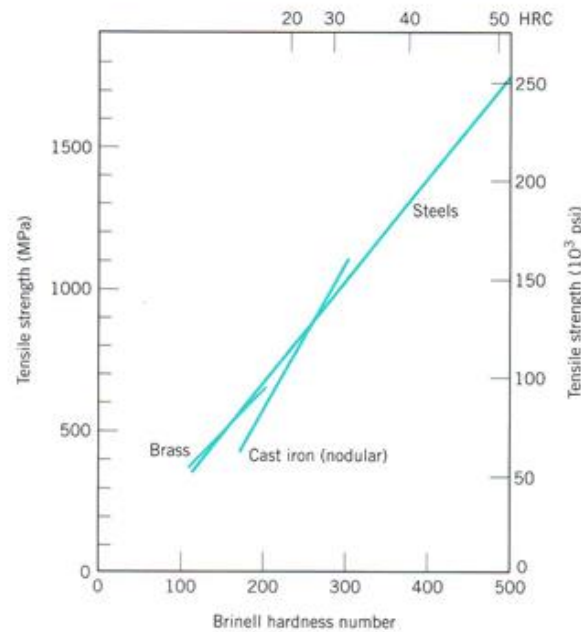
Fig. 7. Hardness and tensile strength for steel, brass, and cast iron [12].

Relationships between hardness and tensile strength for steel, brass, and cast iron, see Fig. 7. Simple formulas can also express as Tensile strength (MPa) = 3.45 x HB, or Tensile strength (psi) = 500 x HB.

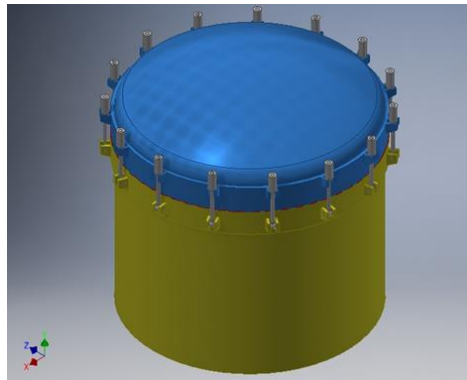
Fig. 8. Modelling of filter vessel structure.

the filter vessel's inner diameter and the dome cover's thickness, were determined based on measurements during the site visit—the bolt's dimension was obtained directly from prudent measurements. As mentioned previously, the bolt material is Carbon steel: 1.25Cr – 0.5Mo, and the tensile strength value can be generated based on a conversion from hardness test results. During the simulation was assumed that all filter machine materials had isotropic and homogeneous material. The mechanical behavior of the material during simulation is considered linear elastic materials.

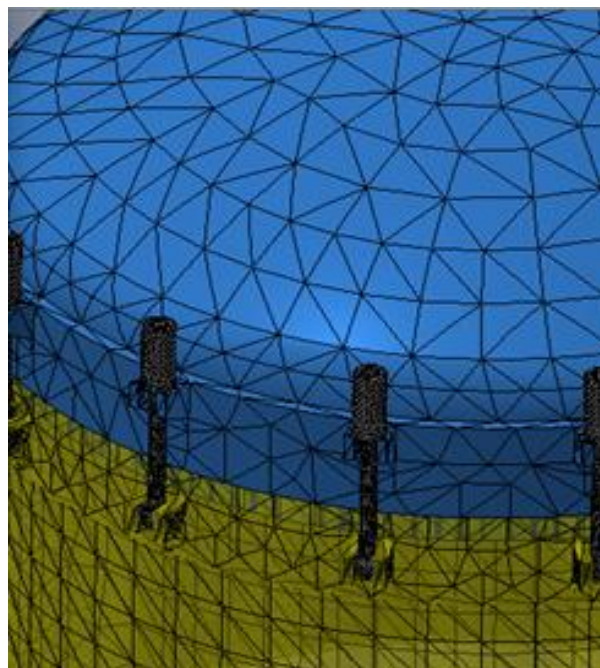
Fig. 9. Mesh generation of the filter vessel structure.

During simulation, the load was modeled as the internal pressure of the vessel, which is about 6 bar as static maximum pressure. The mass of the dome cover and the initial preload acting on the bolts are also considered during the simulation. There are two methods to determine initial tensile loads that are based on bolt diameter and the percentage of yield strength of bolt material. A comprehensive study of the externally bolted joints was conducted analytically, computationally, and experimentally [14]. Contacts between components have also been adjusted. The mesh has an average element size parameter of 0.1, a minimum element
